Effects of Hydraulic Stimulation on Coalbeds and Associated Strata

Report of Investigations 8260

By Curtis H. Elder

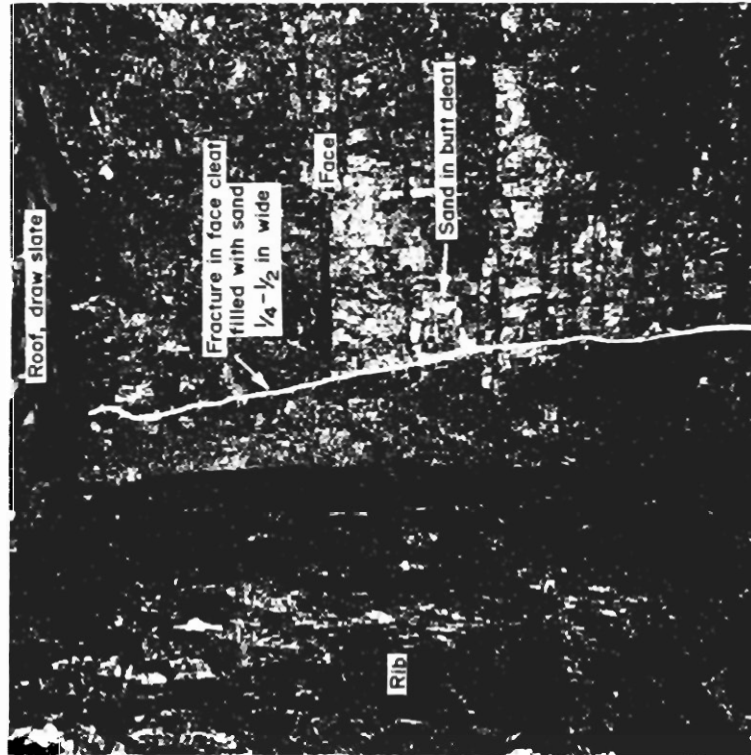
On June 12, 1974, the induced fractures were intercepted by mining. Twenty feet of vertical sand-propped fracture was mapped along the face cleat direction west of the borehole. The sand-filled fracture ranged from one-eighth to one-half inch in width, extending from the draw slate at the top of the coalbed to the mine floor. There was no evidence that the fracture extended into the roof or floor rock (figs. 4-6). Wide vertical fractures were propagated to the north of the borehole along the butt cleat direction. These fractures were 1/2 to 2-1/2 inches in width and were packed with the propping sand (figs. 7-8). They extended from the base of the draw slate to the floor. Again, no evidence was found to indicate that the induced fractures along the butt cleat direction penetrated the roof (fig. 9) or floor rock.

FIGURE 6. - Induced fracture in face cleat of Pittsburgh coalbed. Note termination of fracture at draw slate.

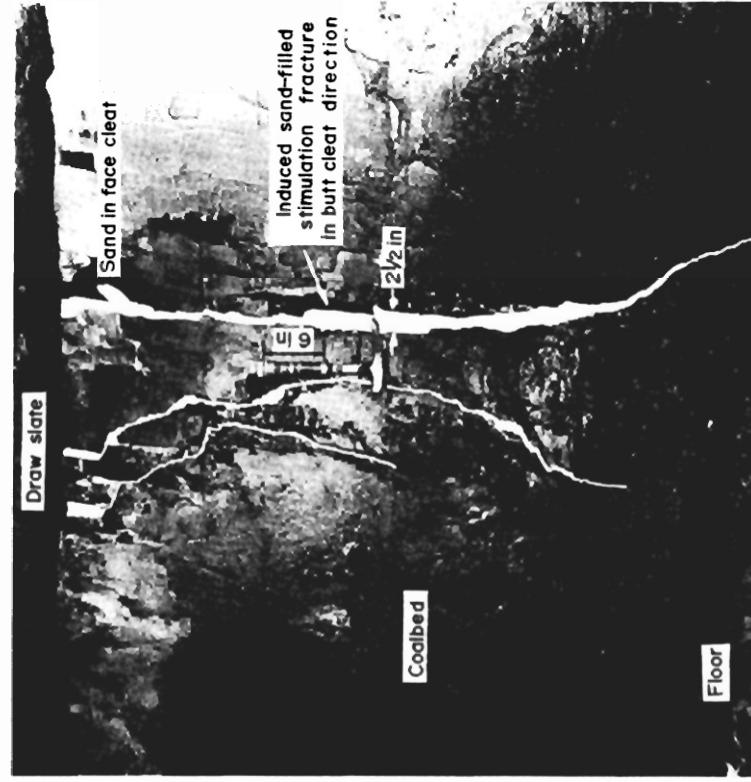
FIGURE 7. - Induced sand-filled fractures in butt cleat direction in Pittsburgh coalbed.

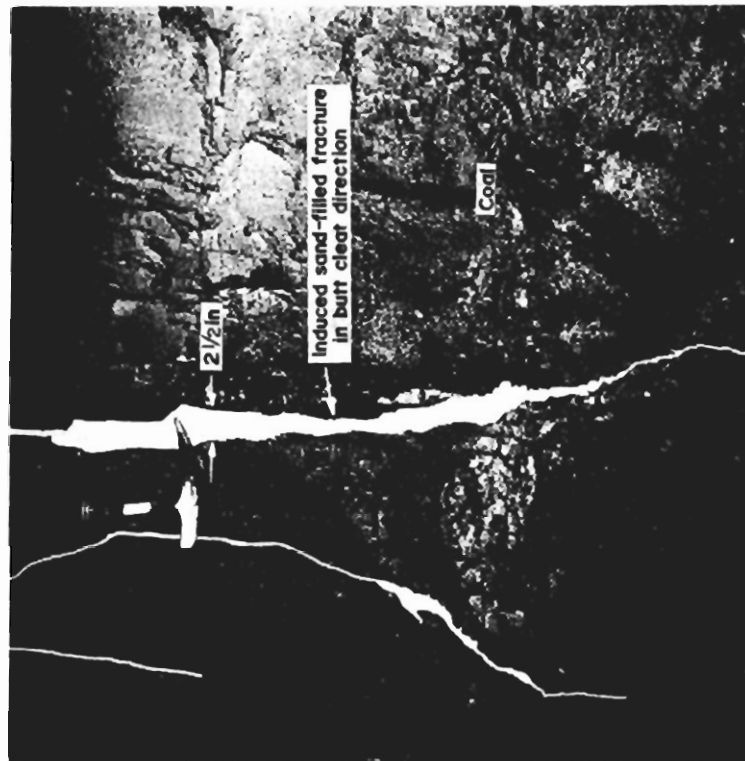
FIGURE 8. - Detail of induced fracture in middle of Pittsburgh coalbed at maximum width.

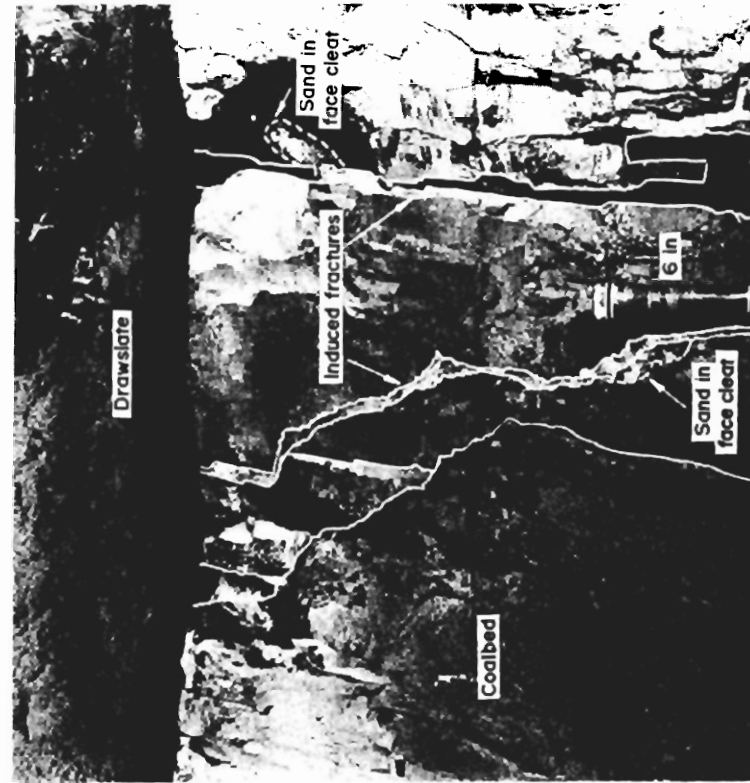
FIGURE 9. - Detail of induced fracture terminating at draw slate or rock strata overlying coalbed. The fracture does not penetrate overburden rock.

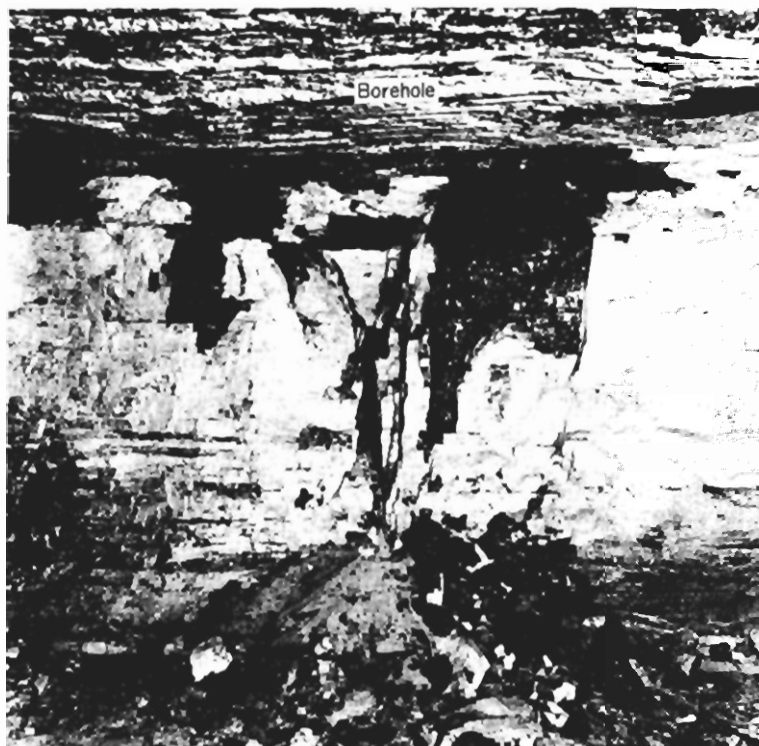
FIGURE 10. - Induced fracture after 2 years of exposure in mine.

The borehole and induced fracture site in the mine were inspected 2 years after treatment to observe long-term effects of stimulation on the roof strata and coal rib. No deterioration of roof or floor strata was evident. In addition, no spalling was observed along the roof or coal rib (fig. 10).

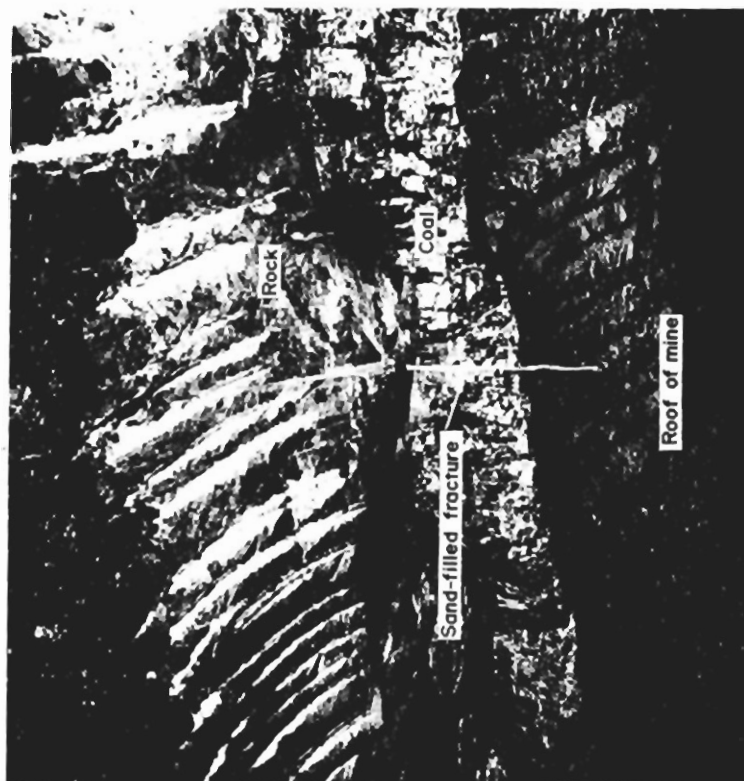
The fracture could be readily traced across the entries of the roof coal. It ranged from one-eighth to three-eighths inch in width, averaging approximately one-quarter inch (figs. 15-18). The sand-propped fracture did not extend into the roof or floor. The roof coal and rock remained stable in all the entries intersecting the fracture. Mining developed normally through the stimulated areas. Mine engineers noted a reduction in gas emission into the mine in the test area resulting from a long period of degasification prior to mining. Approximately 61 cu ft of fracture volume was created which was filled with sand. Sixty-four cubic feet of sand was used during the treatment. The 3-cu-ft difference can be attributed to sand that settled in the borehole. The excess sand was removed from the borehole immediately after treatment.

FIGURE 16. - Detail of induced fractures in roof coal and termination of fracture at rock strata overlying coalbed at point A on figure 13.

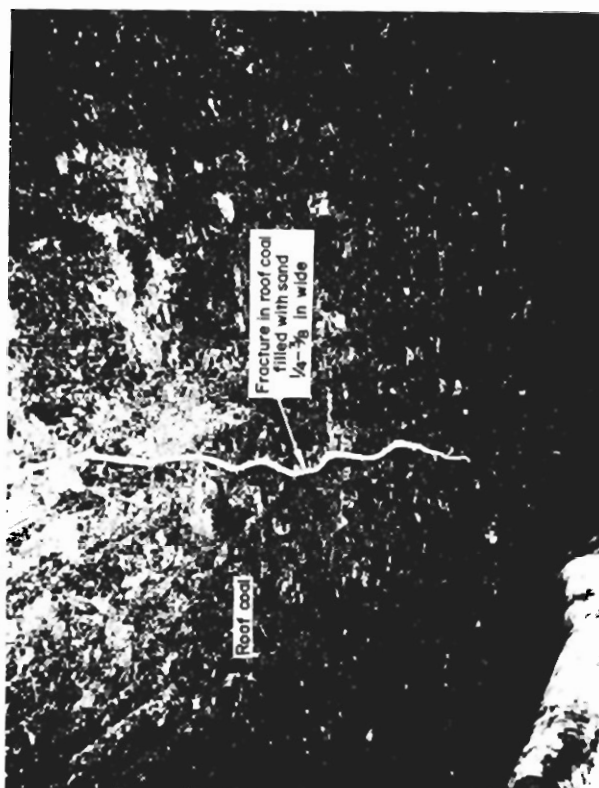
FIGURE 15. - Trace of sand-filled induced fracture in roof coal of mine entry of Inland mine at point A on figure 13.

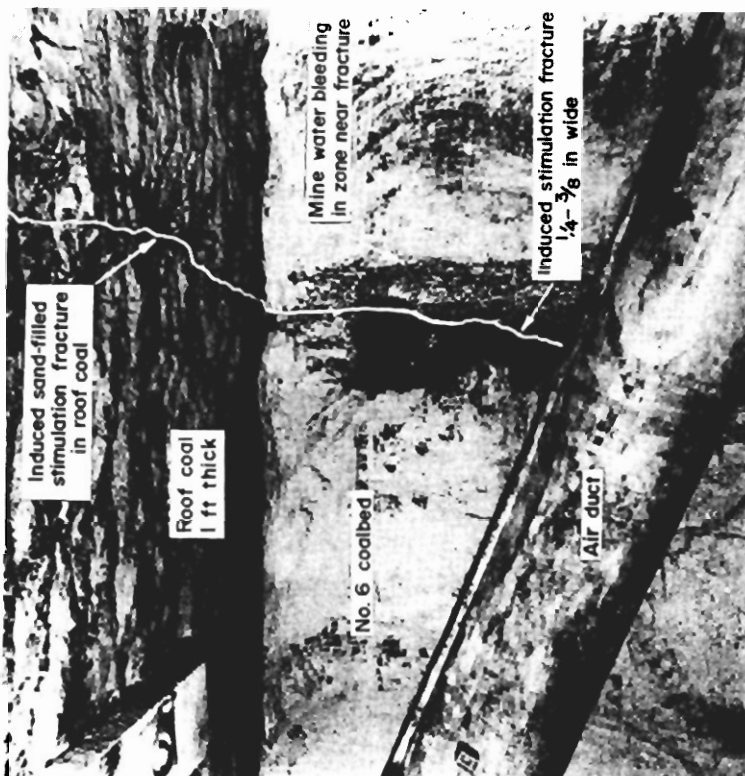
FIGURE 17. - Sand-filled induced fracture in rib and roof coal at point C on figure 13.

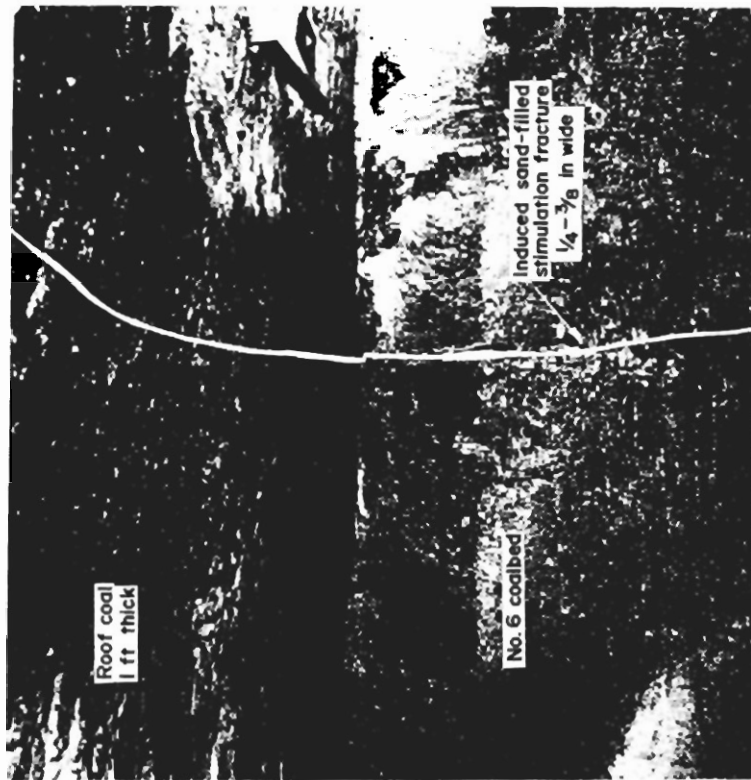
FIGURE 18. - Sand-filled induced fracture in rib and roof coal at point B on figure 13.

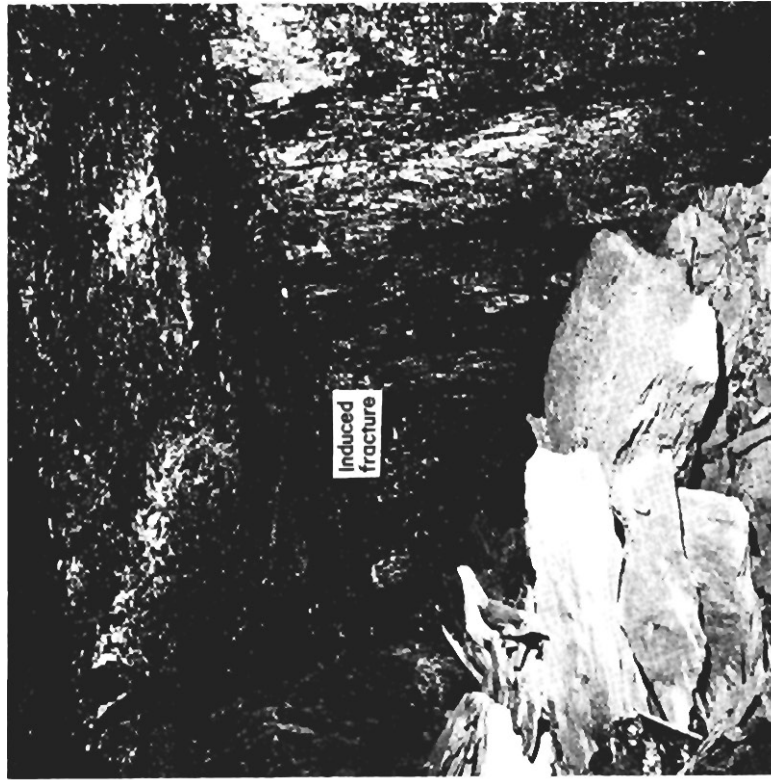
The roof along the east-west bleeder entry at point A (fig. 19) had remained stable. There had been no spalling of roof or coal rib along the trace of the induced fracture (fig. 20).

FIGURE 20. - Induced fracture after 2-1/2 years of exposure to mine atmosphere at point A on figure 19.
